Appendix F

Structures Visual Inspection Forms

FACILITIES CONDITION ASSESSMENT REPORT

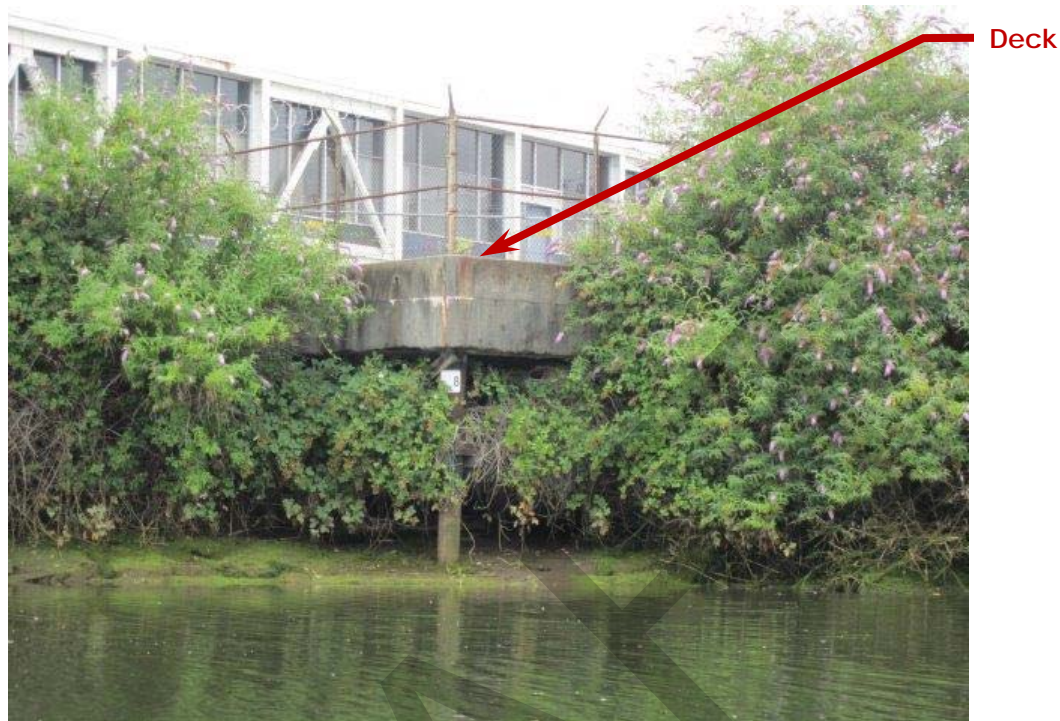
Photo ST07-01: North (Down Stream Looking East) –most Structure

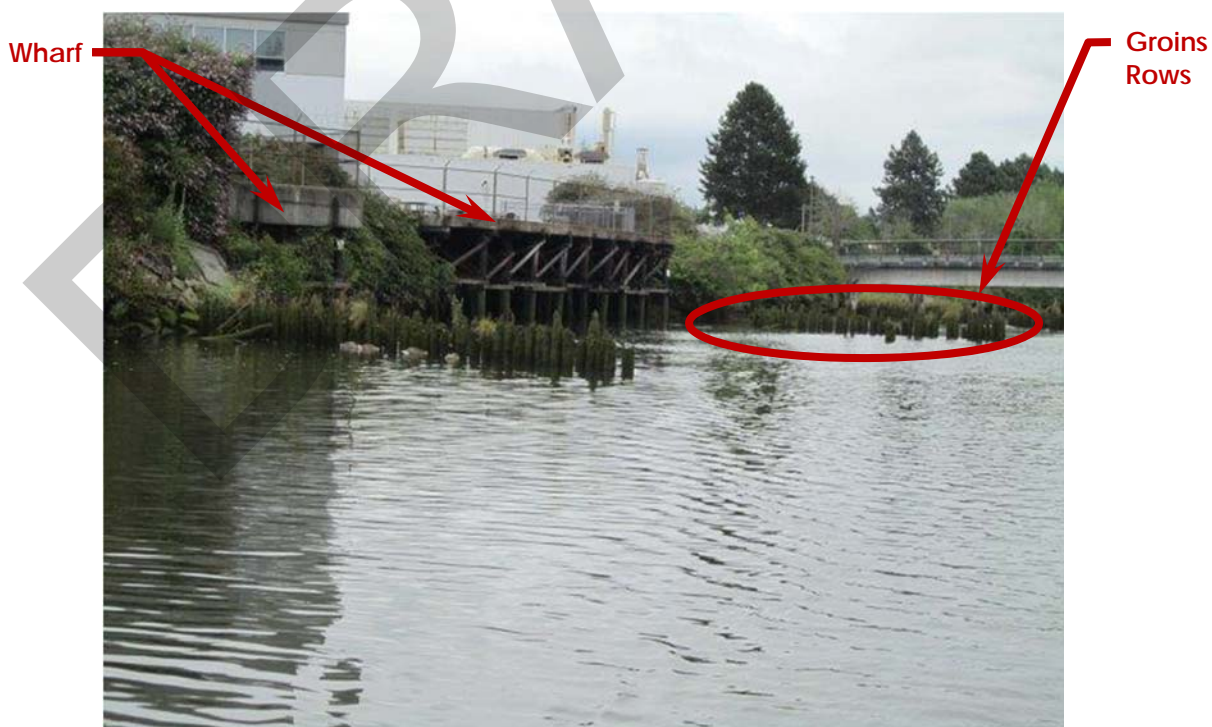
Photo ST07-02: Wharfs (Looking East)

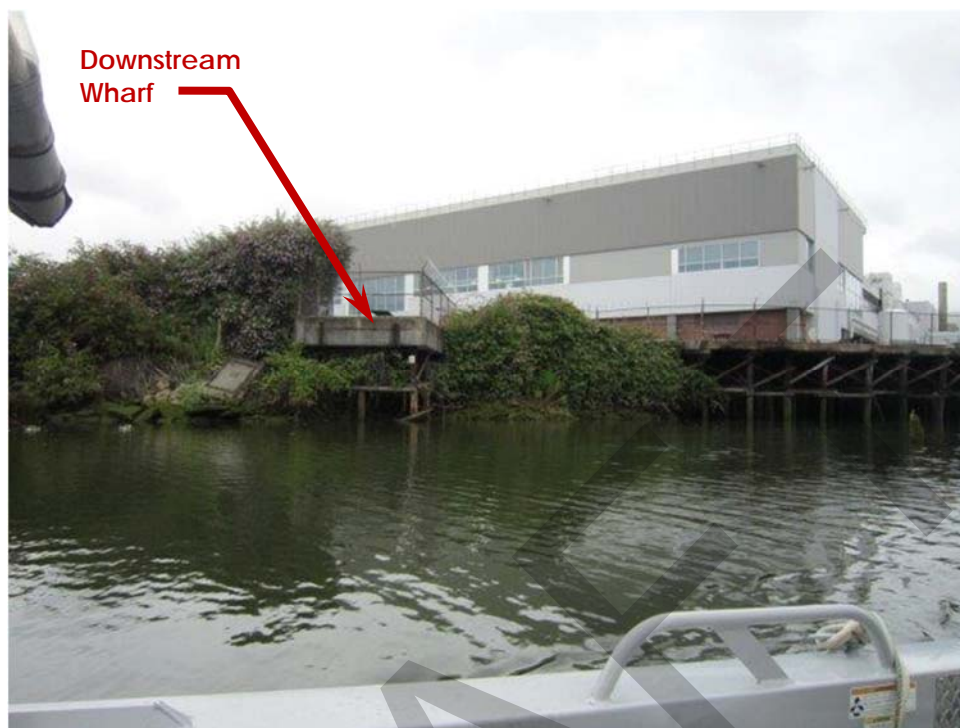
Photo ST07-03: Smaller Wharf

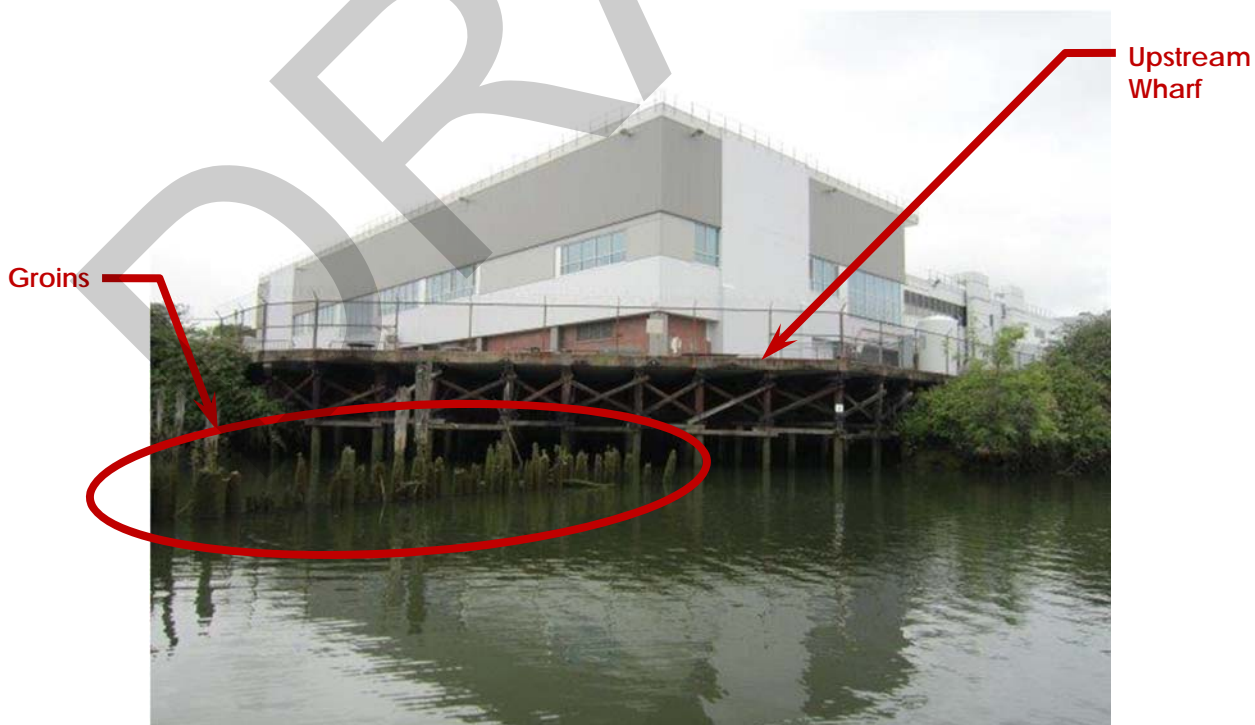
Photo ST07-04: Larger Wharf

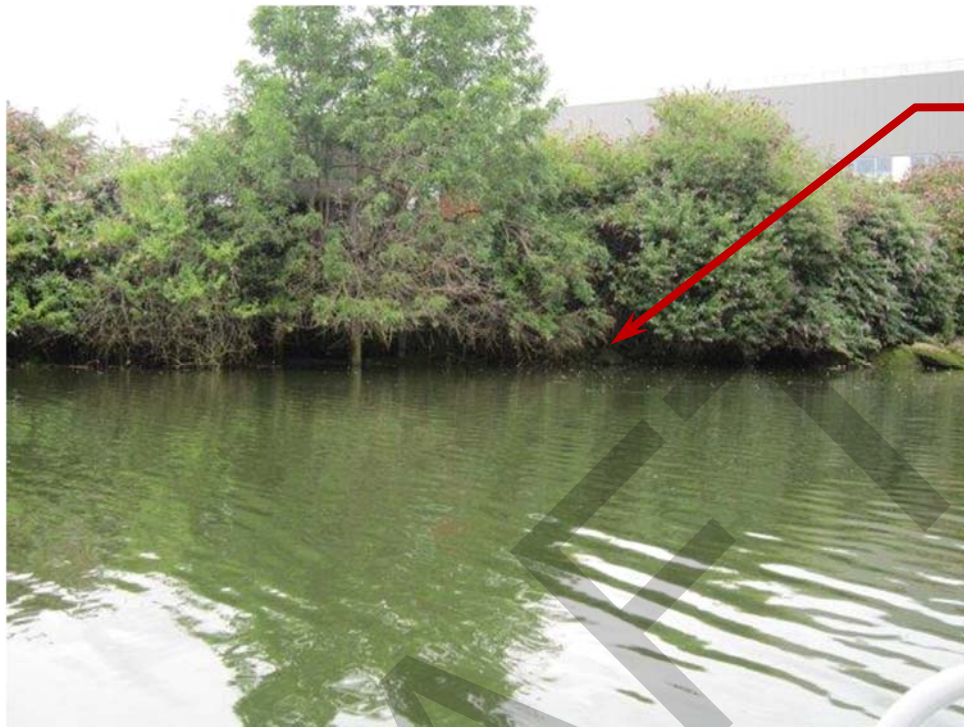
Photo ST07-05: Timber Bulkhead

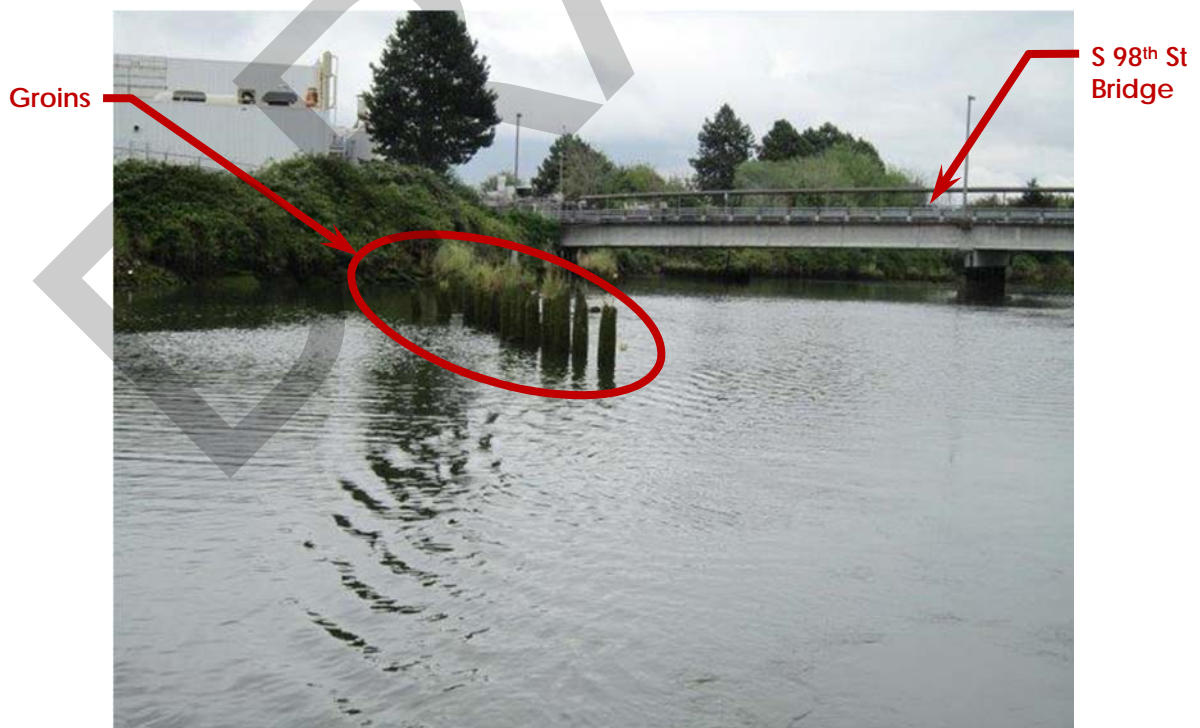
Photo ST07-06: Groins North of Bridge (Looking Southeast)

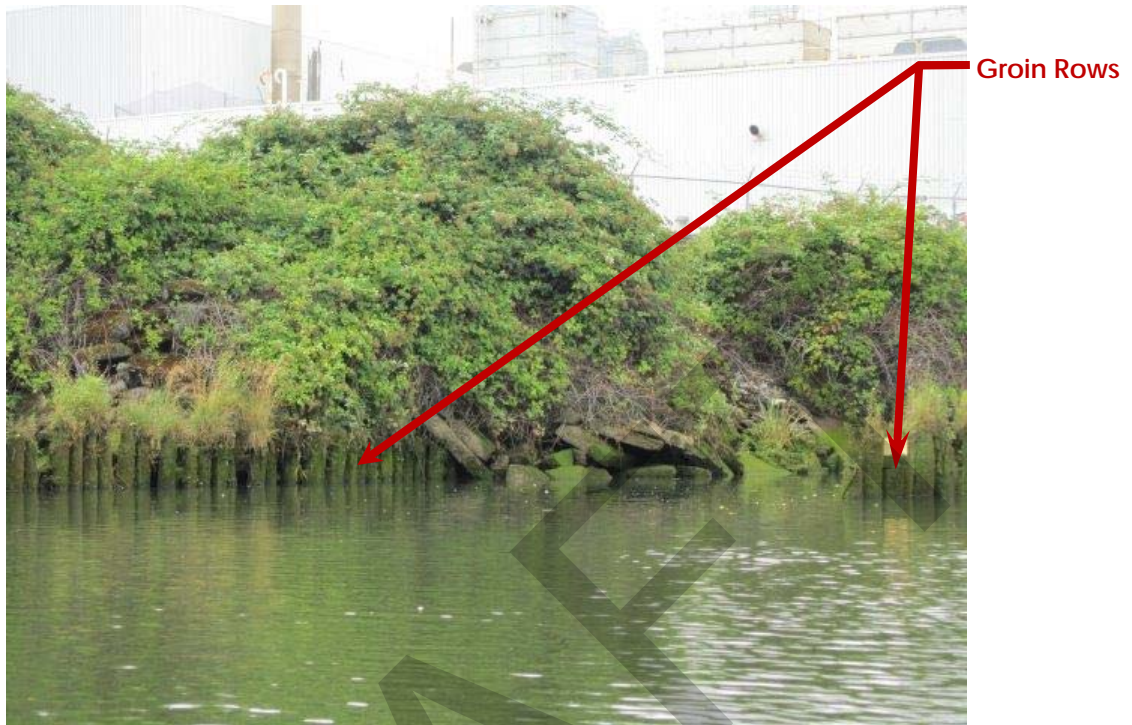
Photo ST07-07: Groins and Embankments North of Bridge

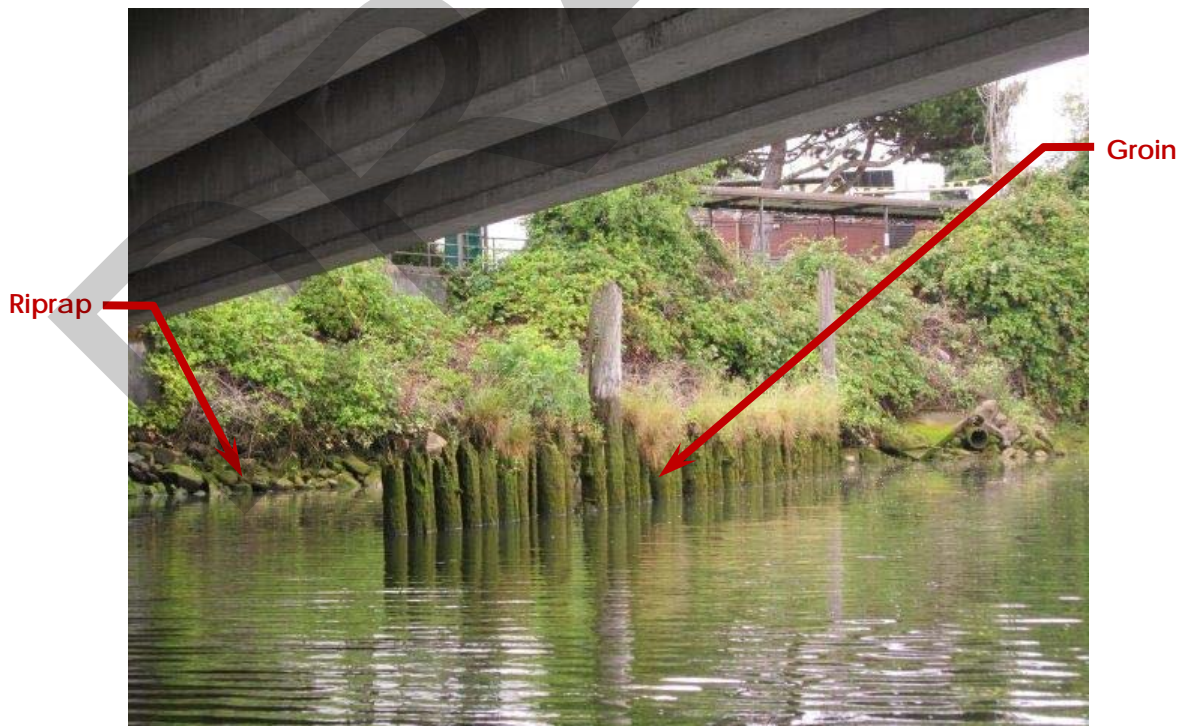
Photo ST07-08: Groins and Embankment South of Bridge

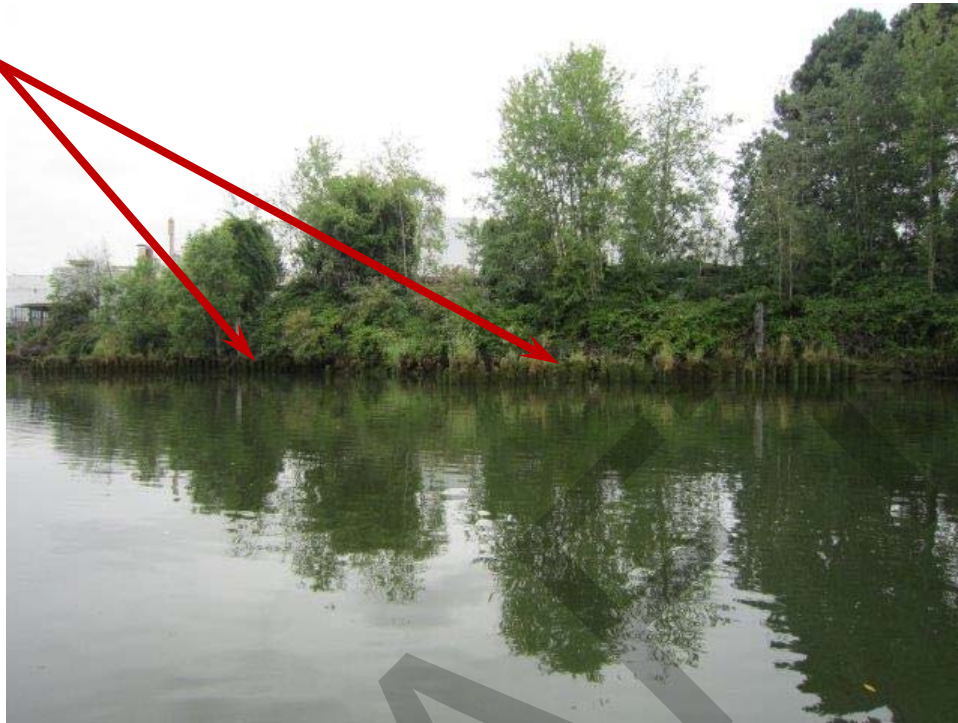
Photo ST07-09: Groins and Embankment South of Bridge

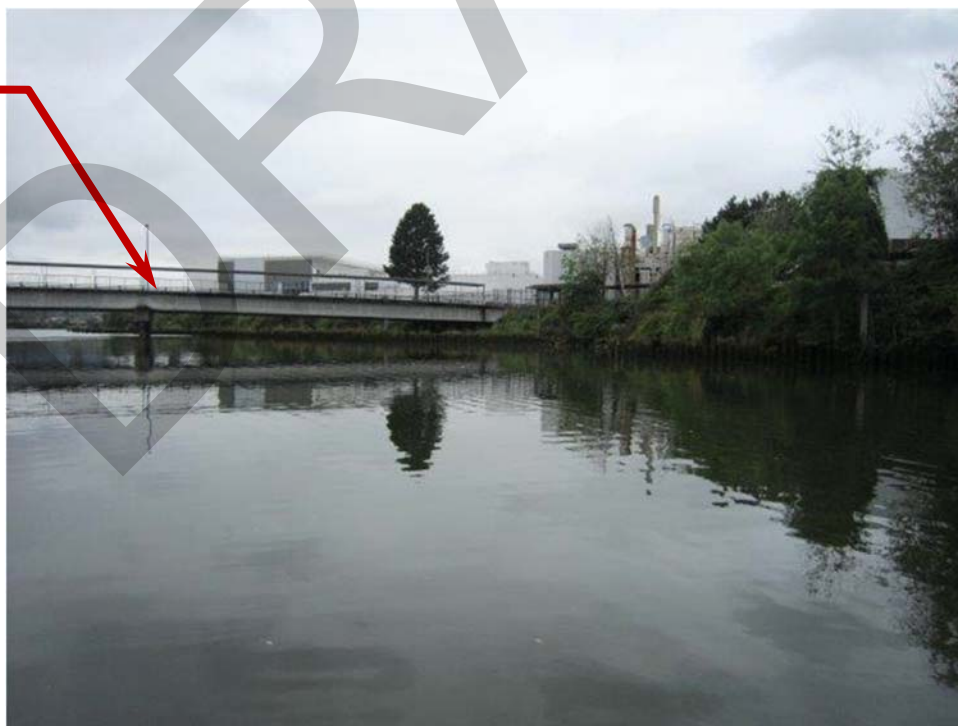
Photo ST07-10: Groins and Embankment South of Bridge (Looking Northeast)

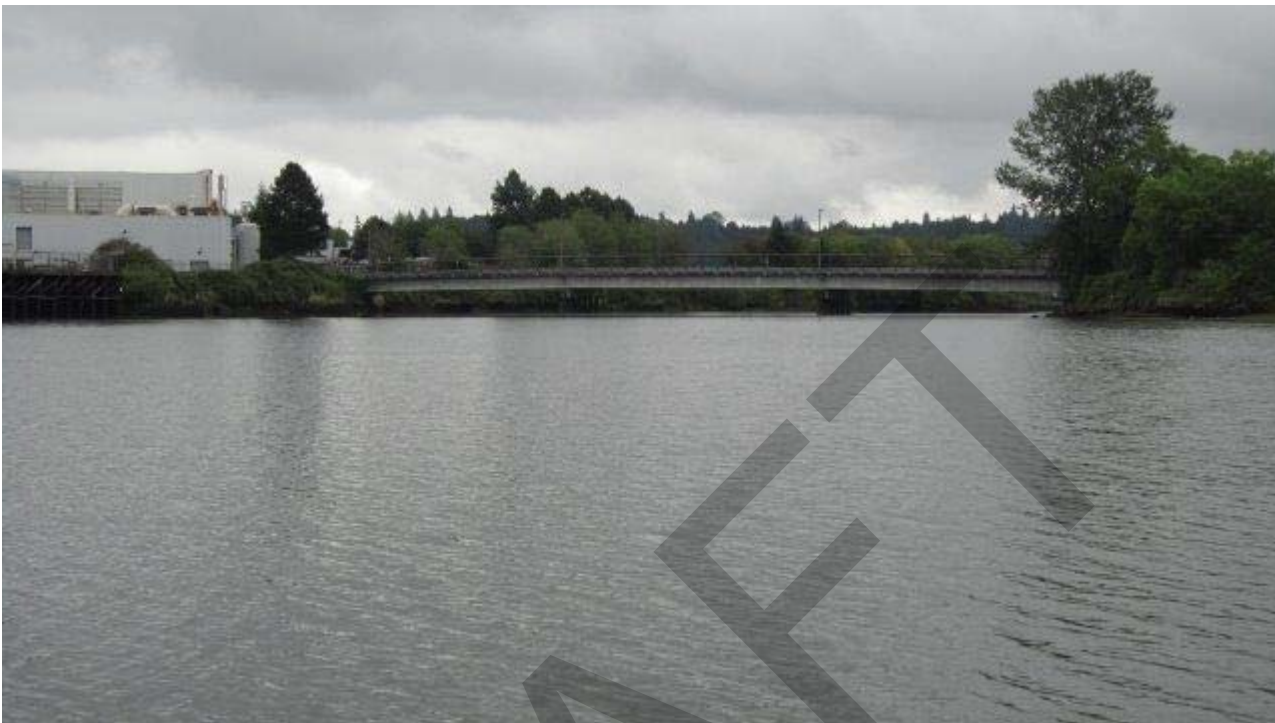
Photo ST08-01: Bridge (Looking South)

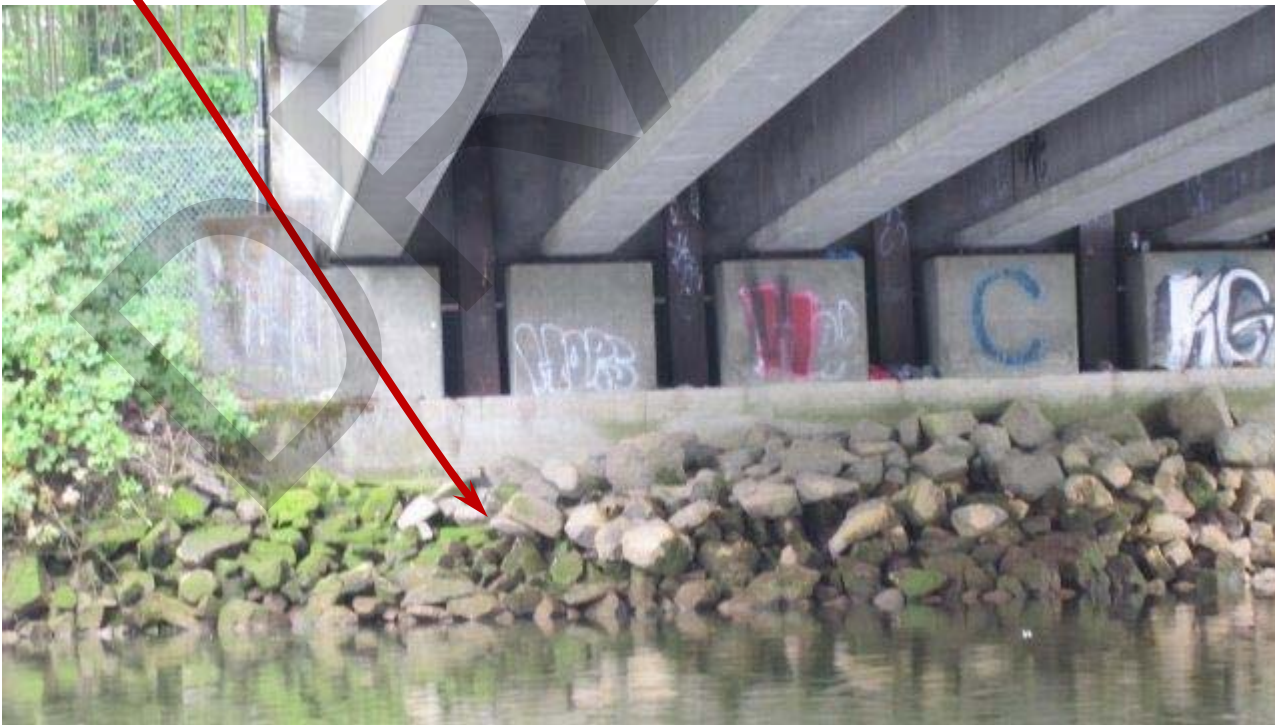
Photo ST08-02: East Abutment

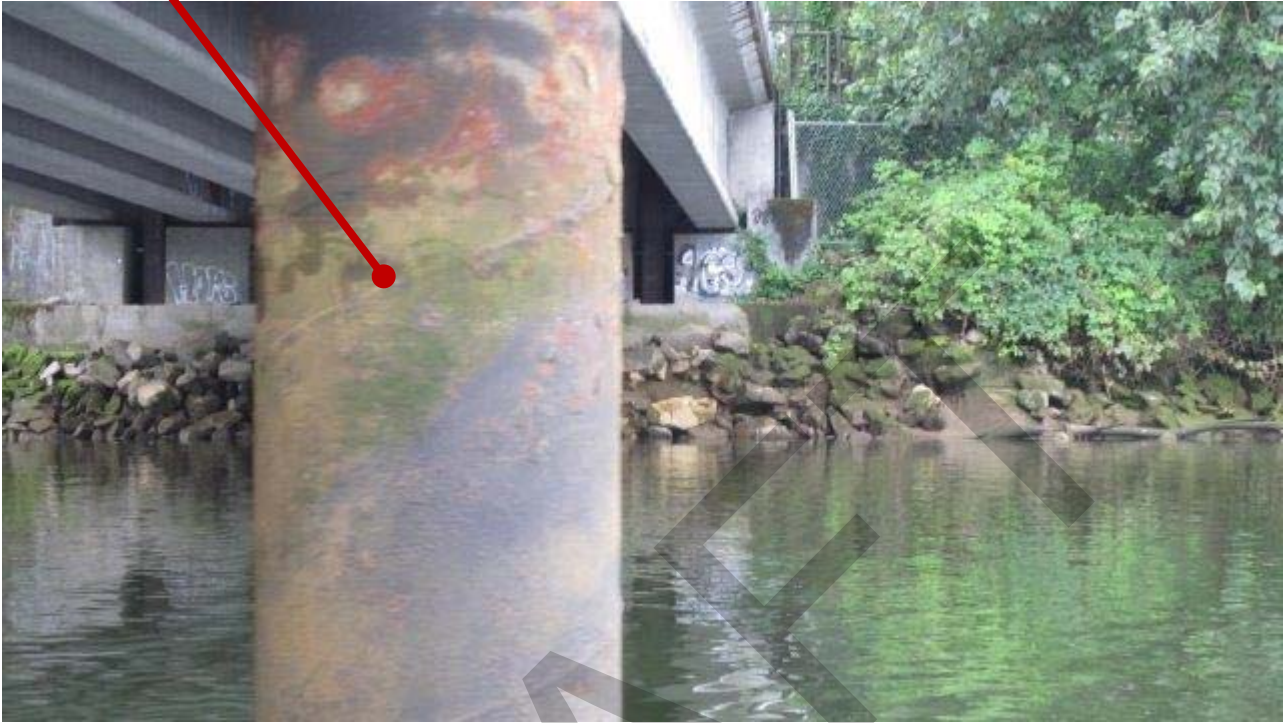
- Three (3)-span concrete girder bridge (Photo 1).
- East and west concrete abutments protected with riprap (Photos 2 and 3).
- Two (2) bents in the navigational channel each consisting of seven (7) steel piers and concrete cap beam (Photos 4 and 5).
- The concrete surface of the abutments and girders appears to be in good condition (Photos 2 to 4).
- The surface of the steel piers exhibits scattered rust and corrosion (Photos 4 and 5).

Photo ST08-05: West Bent (Looking West)

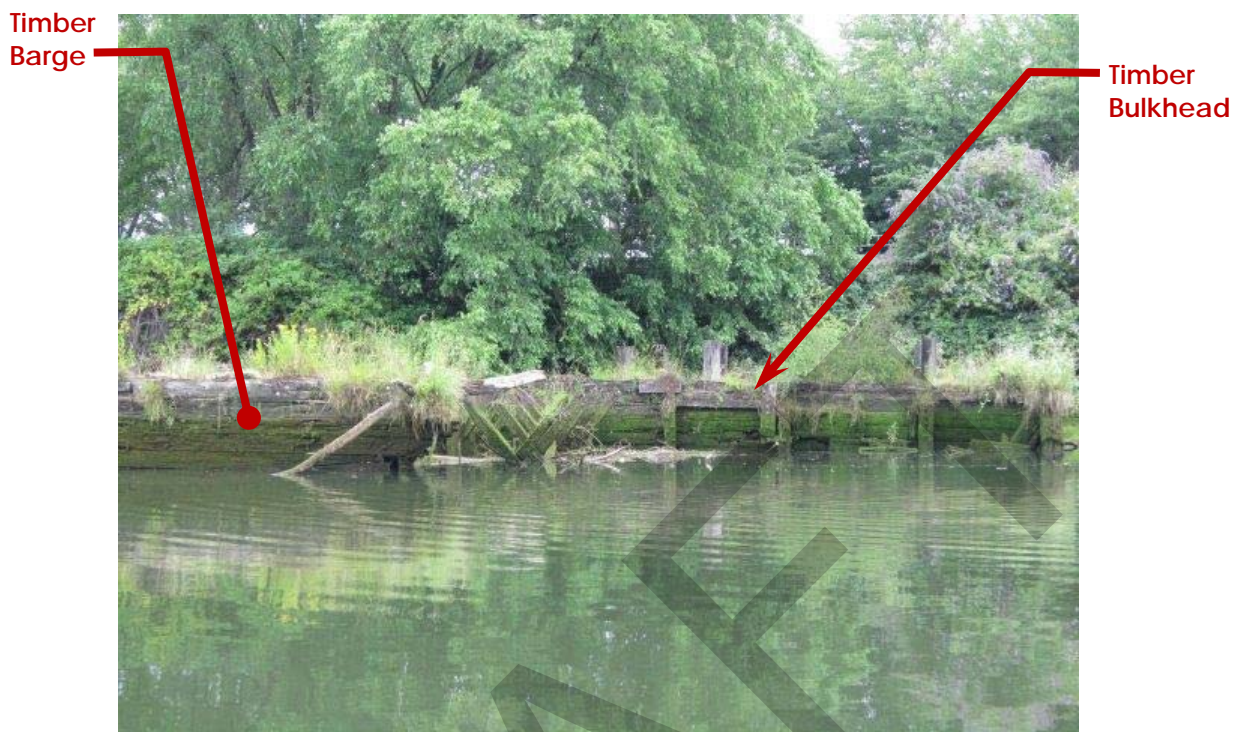
Photo ST09-03: Timber Barge and Bulkhead (Looking East)

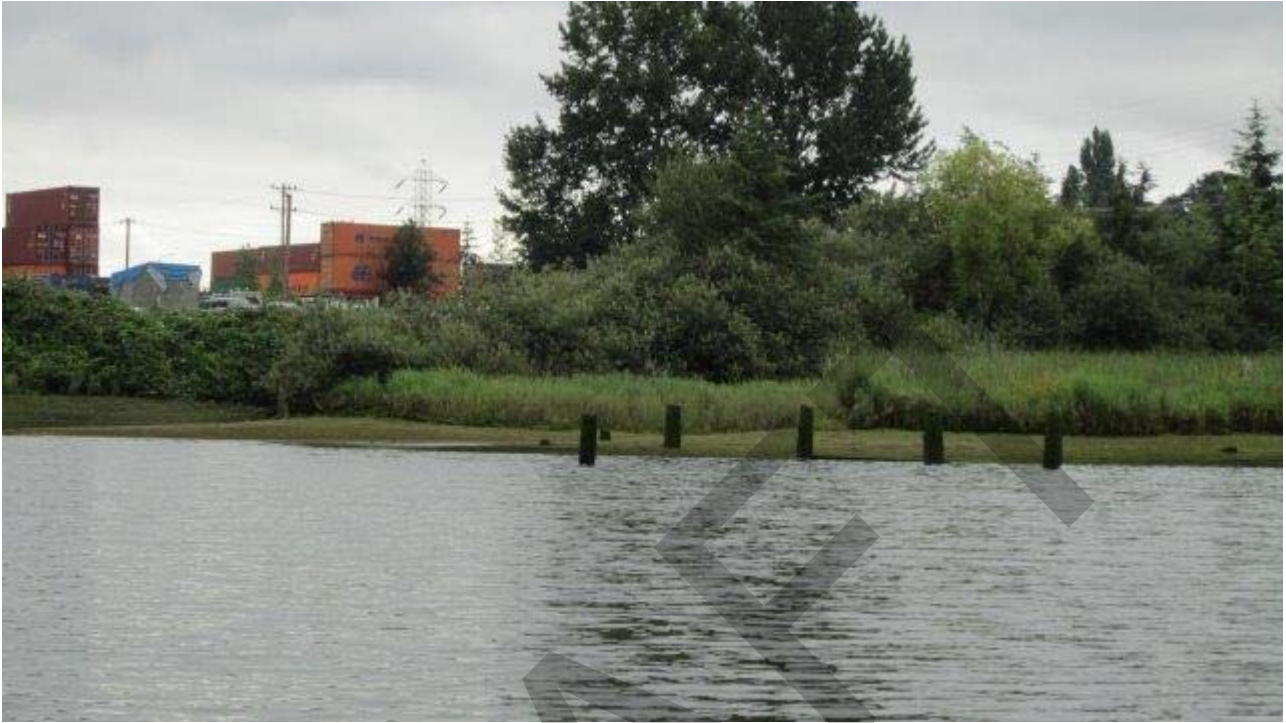
Photo ST10-01: Piles

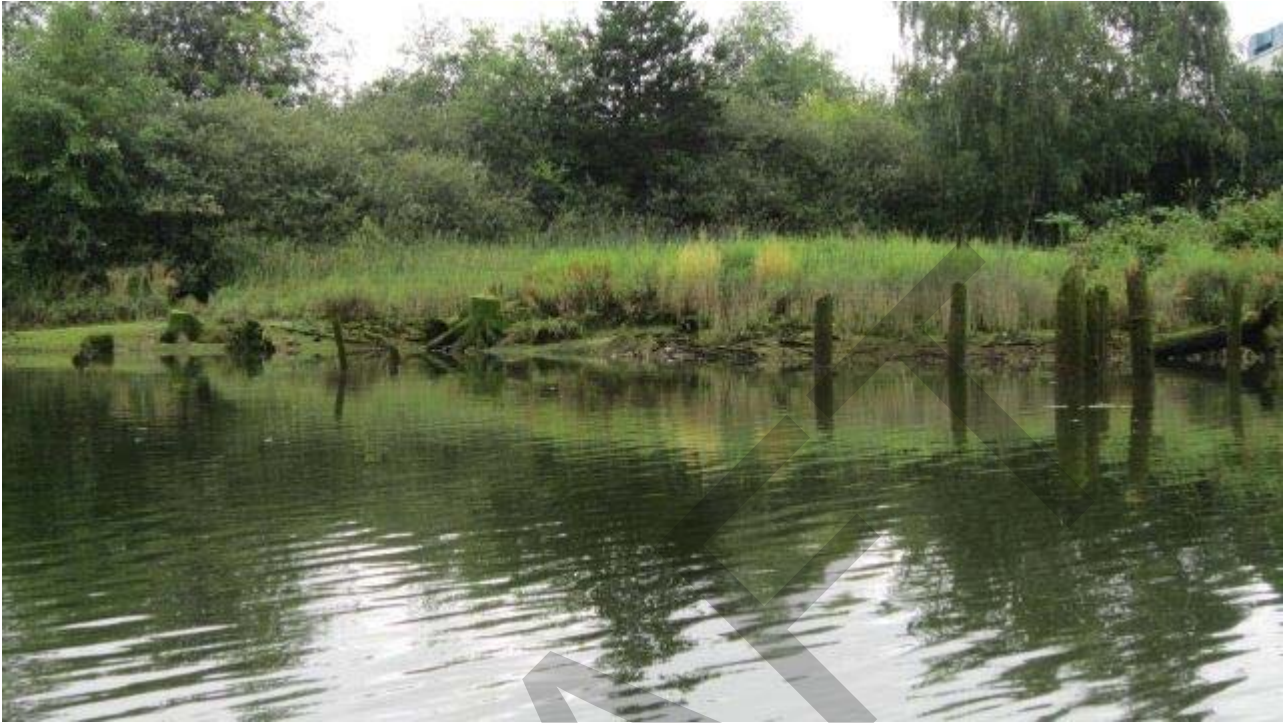
Photo ST11-01: South Pile Field

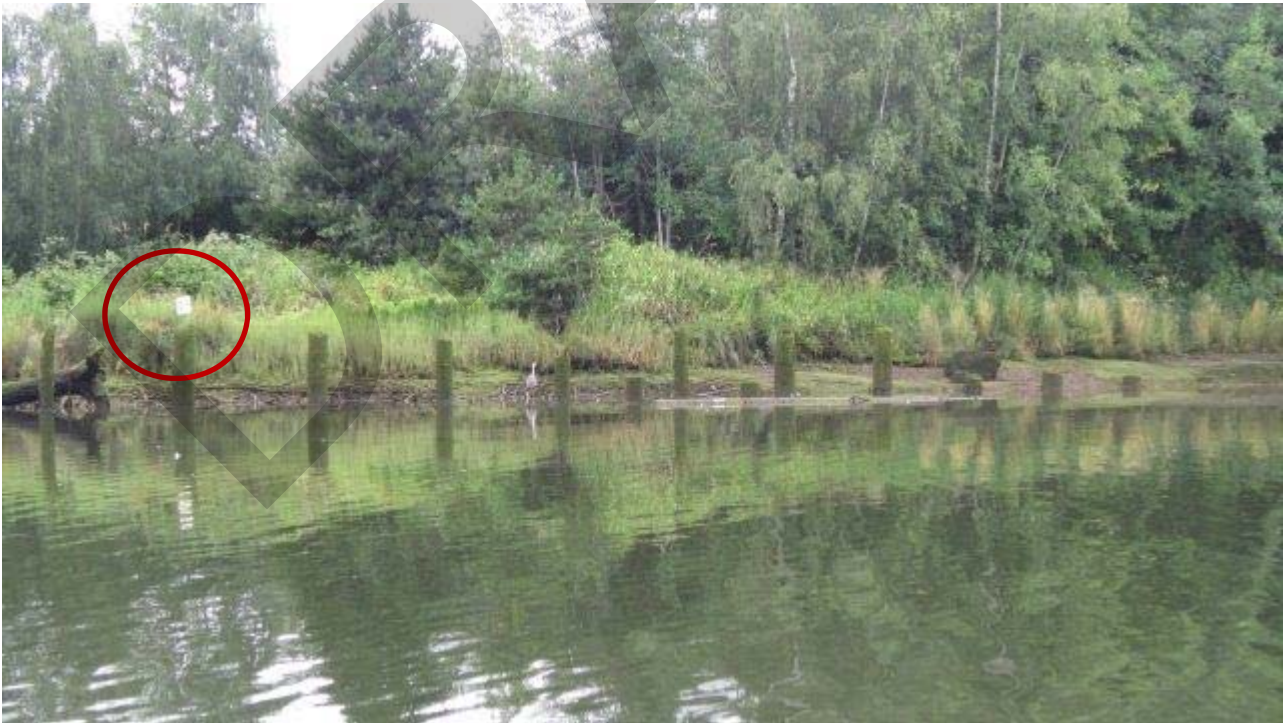
Photo ST11-02: North Pile Field

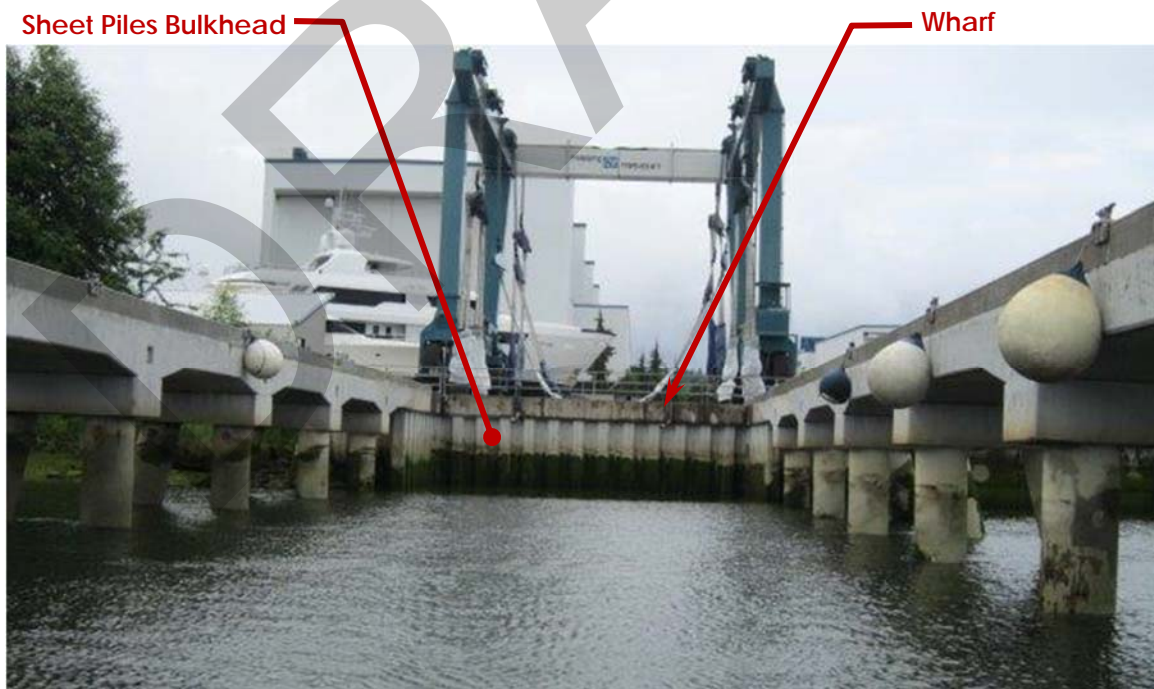
Photo ST12-02: Finger Piers (Looking West)

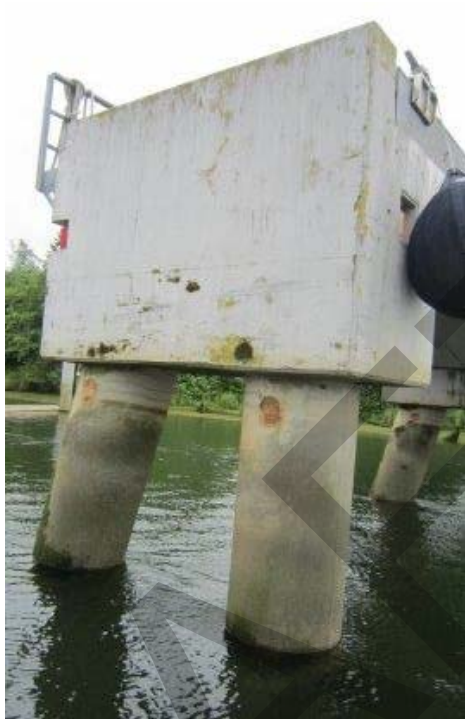
Photo ST12-03: East End Piles and Caps of South Finger Pier

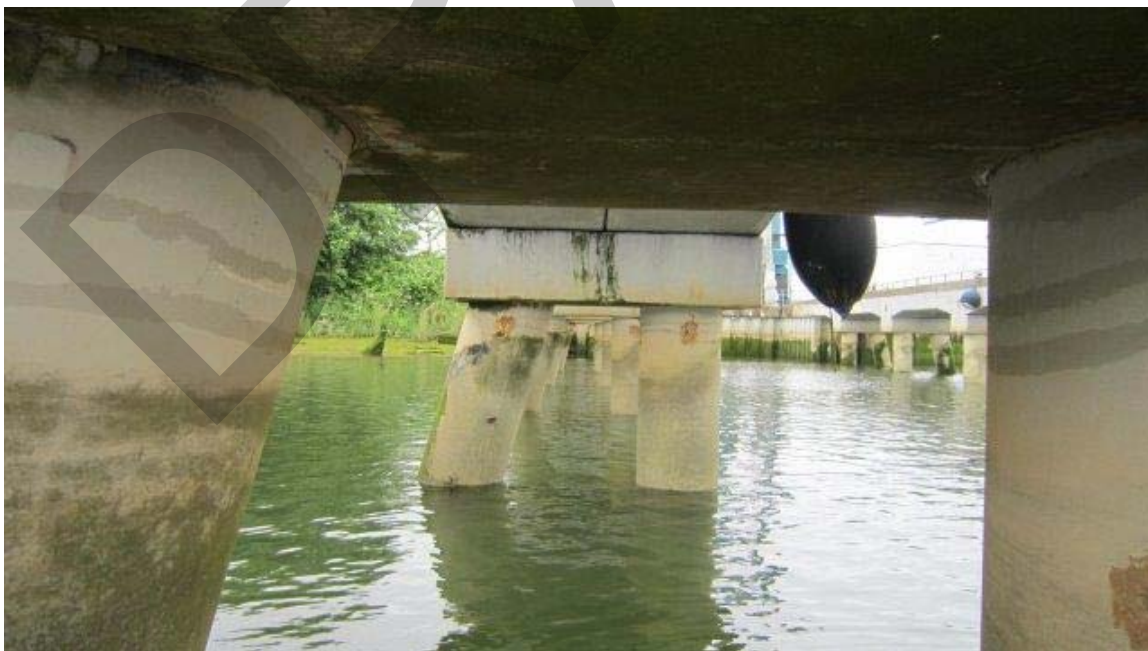
Photo ST12-04: South Pier Pile Rows (Looking West)

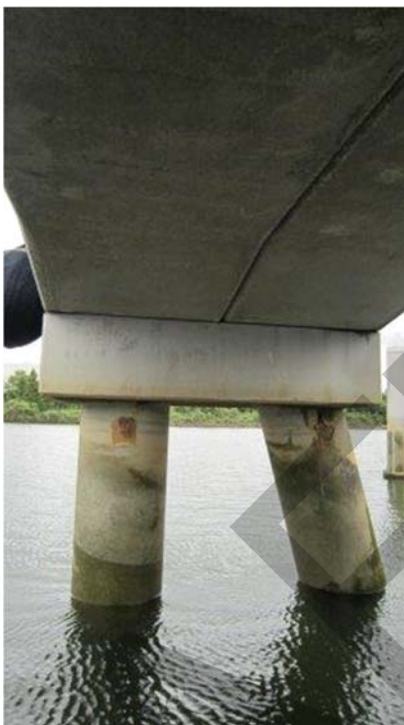
Photo ST12-05: Pile Cap and Pier Decks (Looking West)

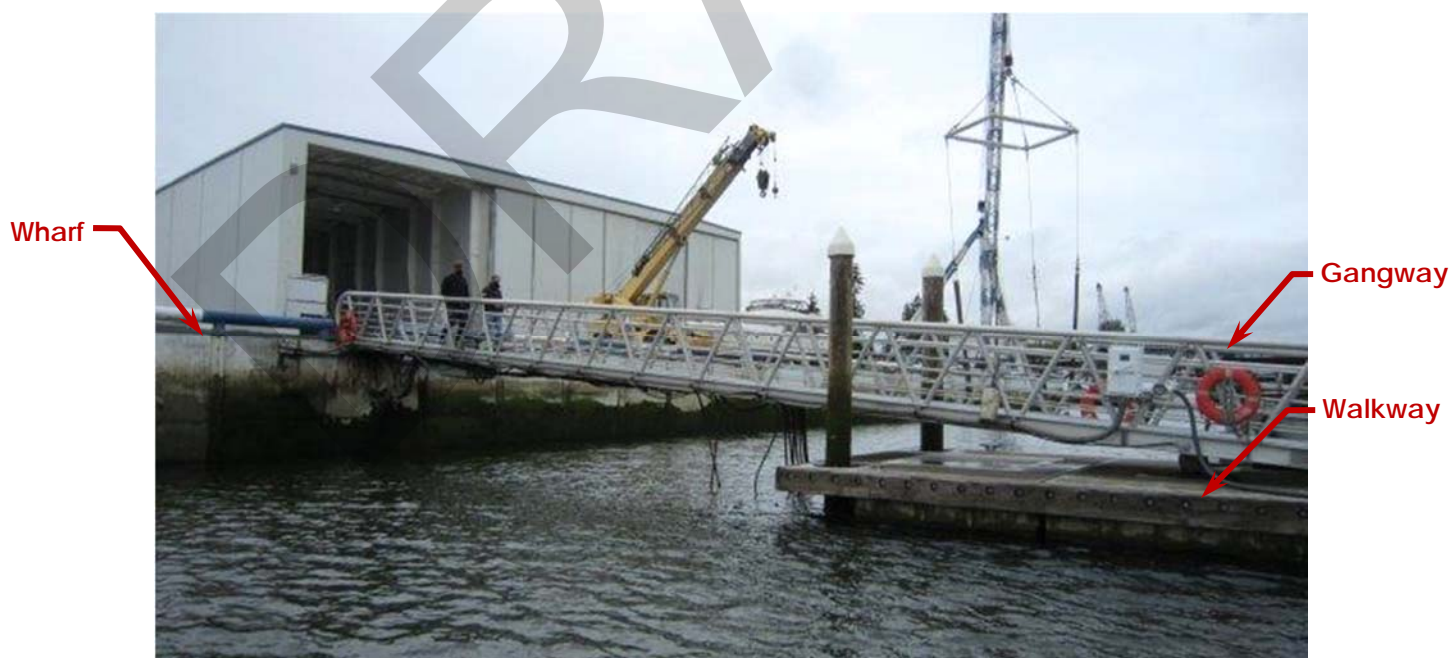
Photo ST12-06: Floating Dock Access Way (Looking North)

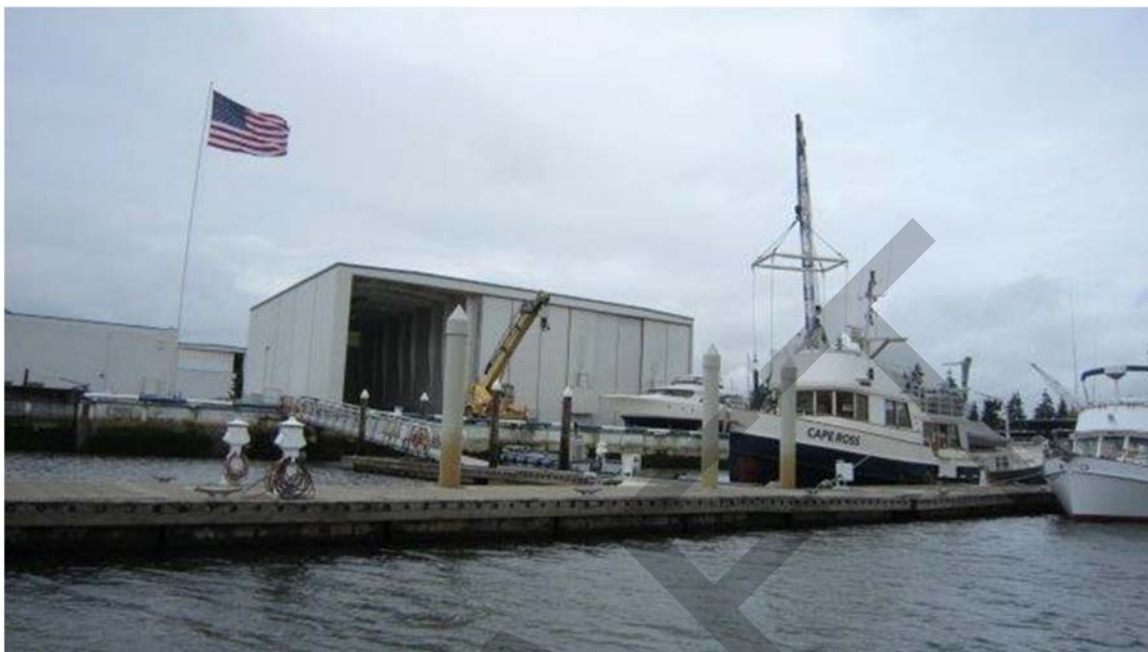
Photo ST12-07: Floating Dock

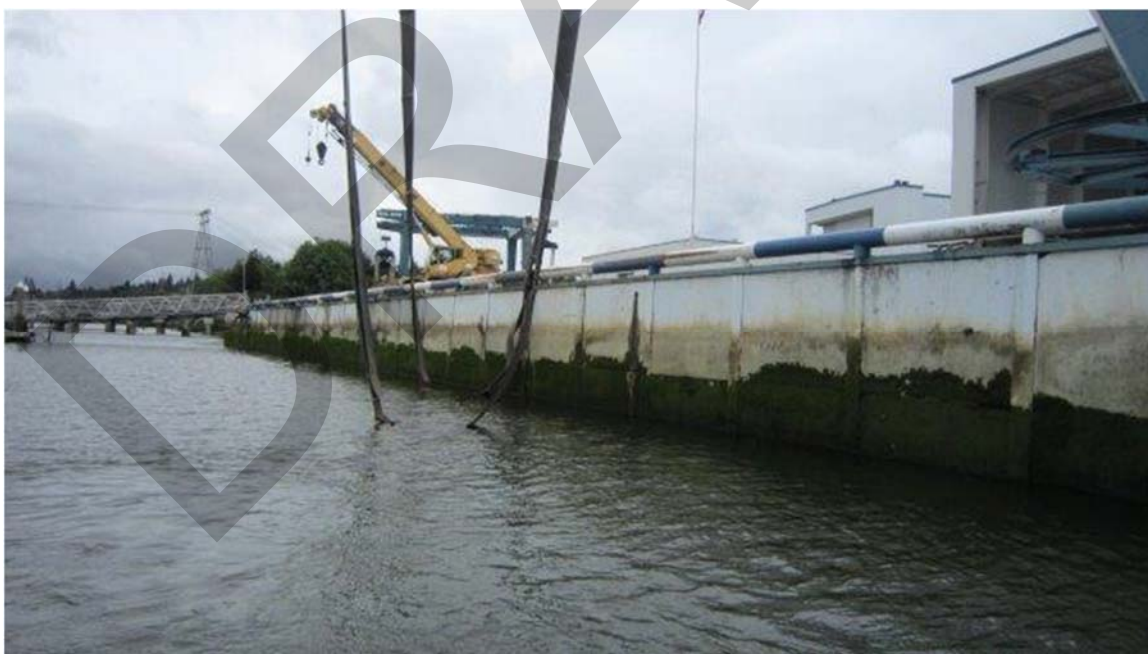
Photo ST12-08: Bulkhead Among Wharf

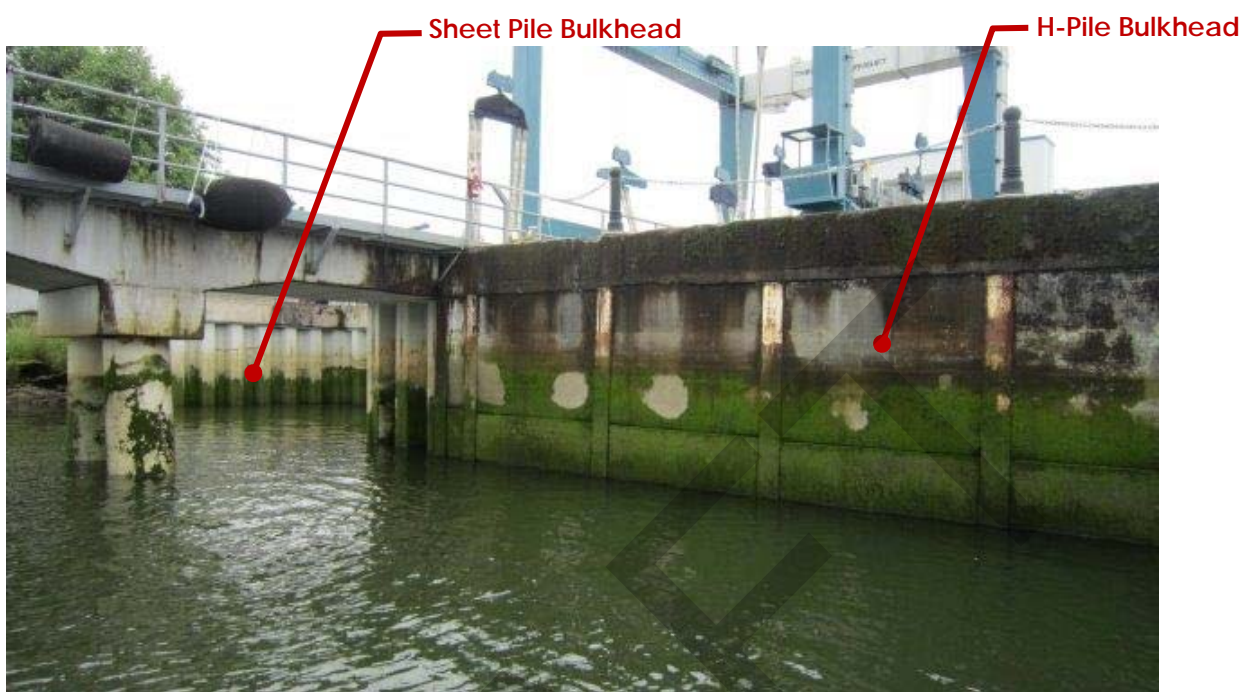
Photo ST12-09: Bulkhead

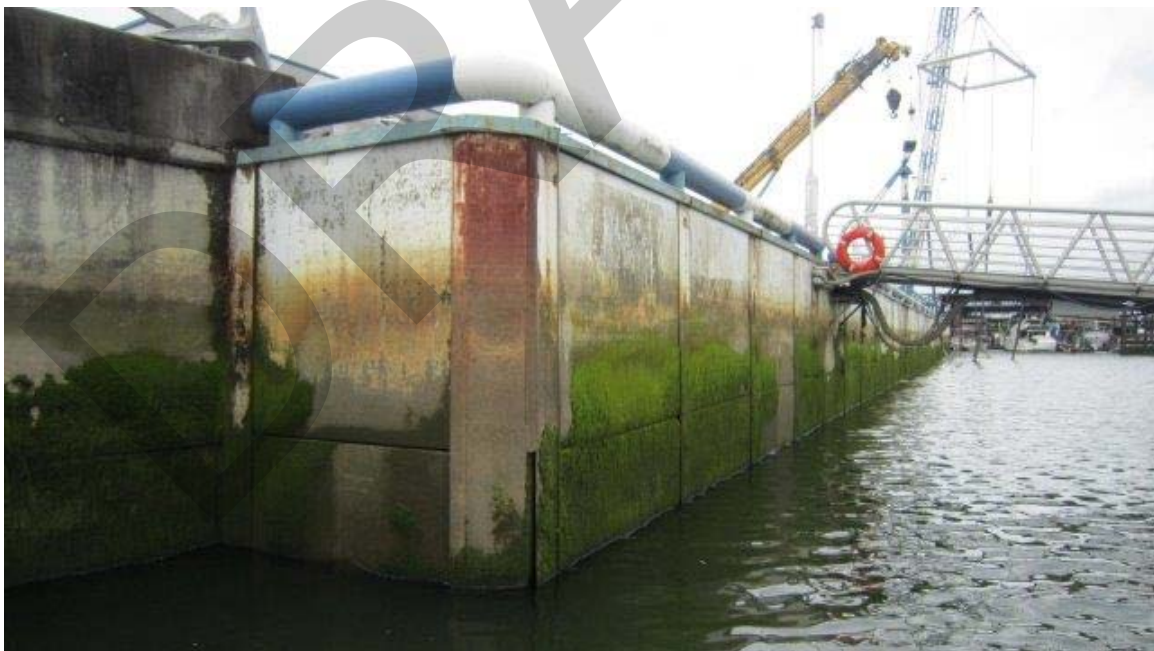
Photo ST12-10: H-Pile Bulkhead (Looking North)

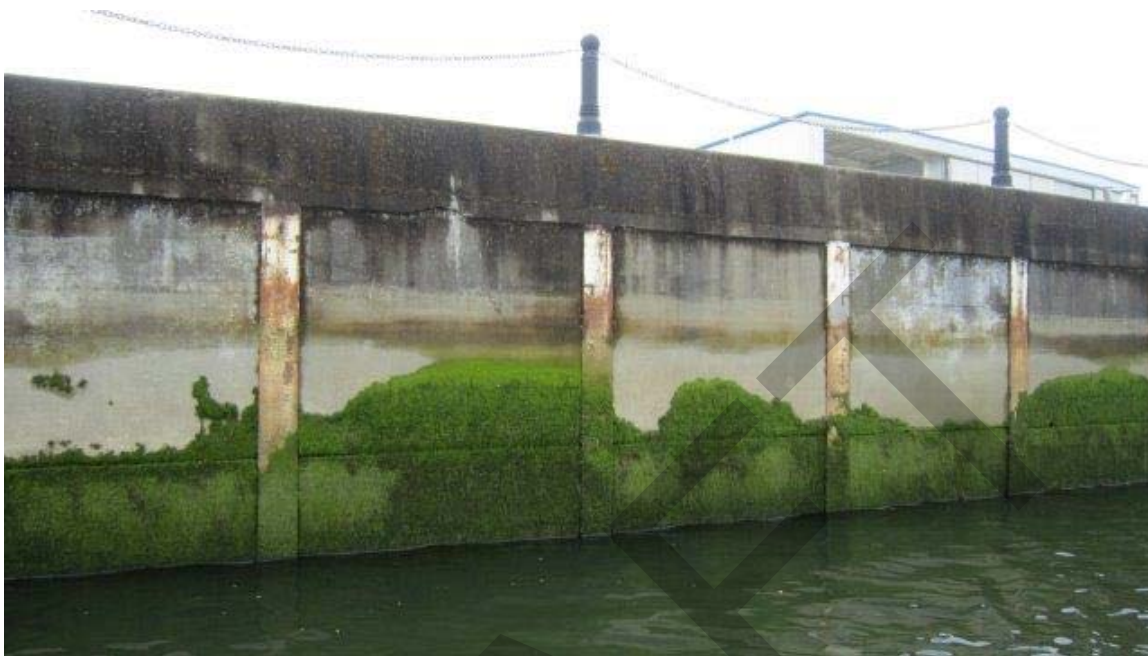
Photo ST12-11: Close Up of H-Pile Bulkhead

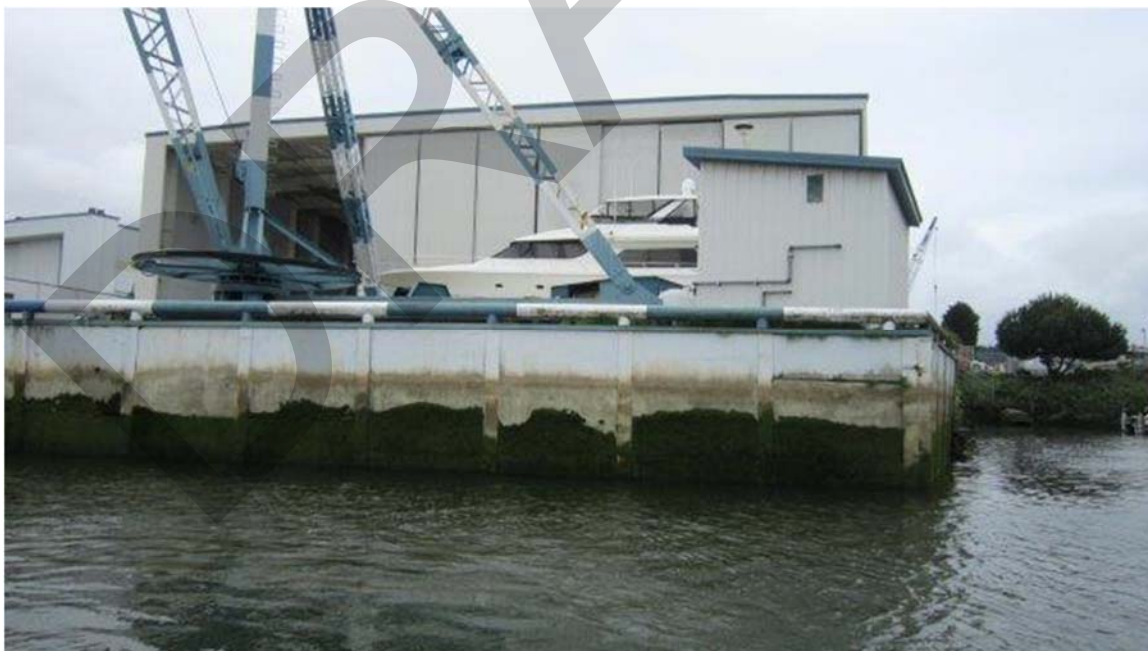
Photo ST12-12: North End Bulkhead and Return (Looking West)

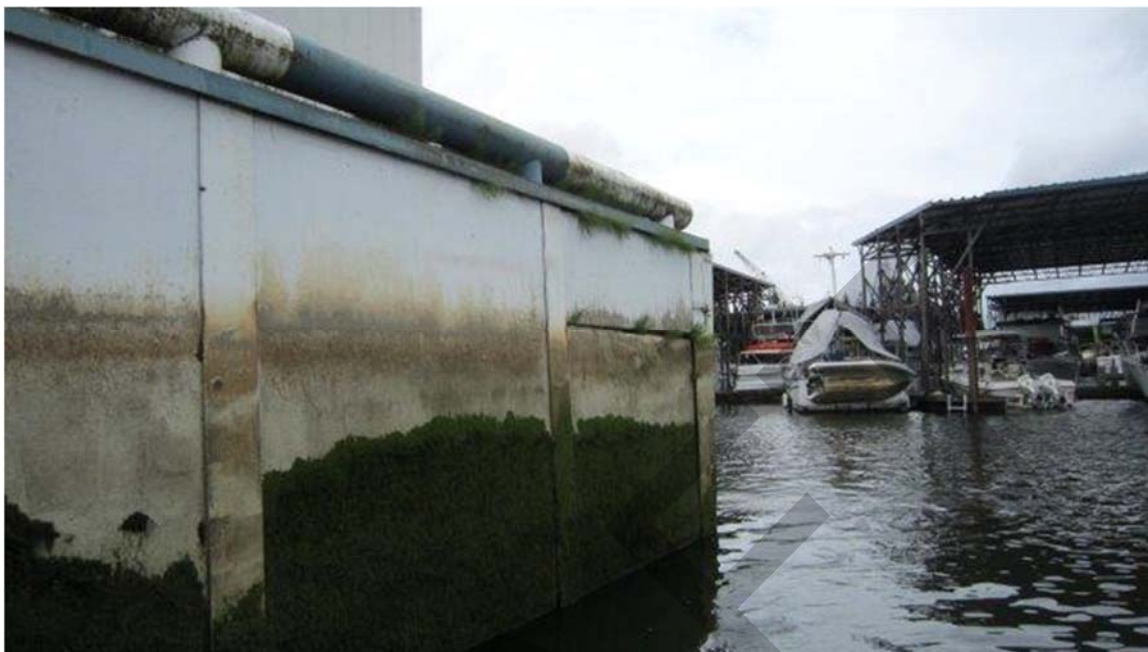
Photo ST12-13: North End Close Up of the H-Pile Bulkhead
